Beachcare groups

in the Waikato region - Coromandel

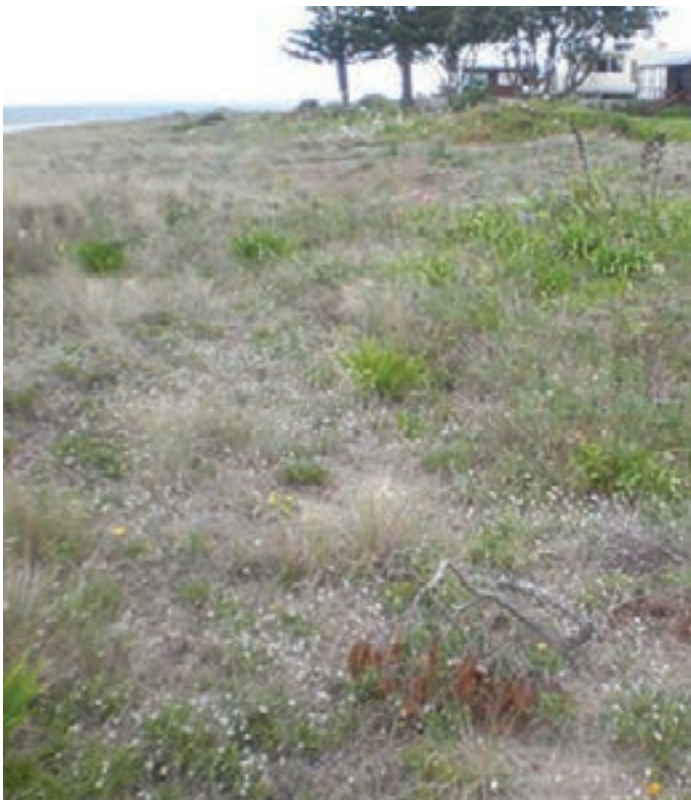
The area was dominated by exotic vegetation prior to work on the demonstration area.

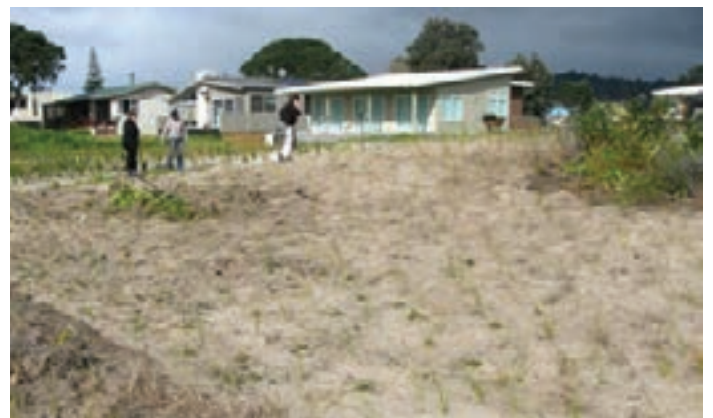
The demonstration area following the final planting working bee in 2011. Further work is planned for 2012.

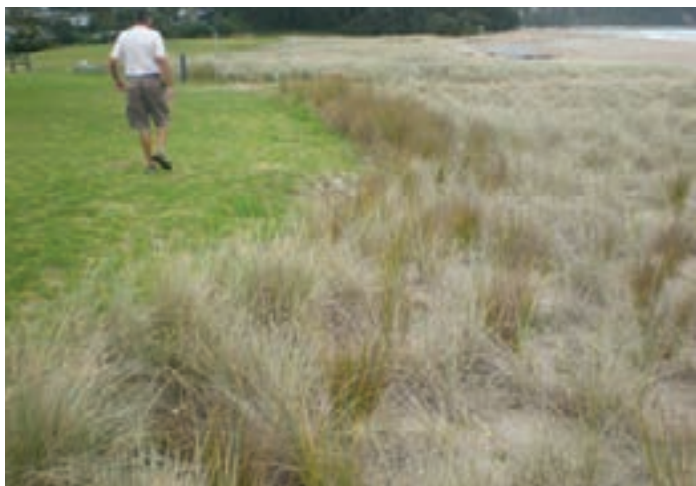
This general view of Onemana plantings in February 2011 shows dense spinifex cover, with a narrow width of wīwī along the landward boundary. The wīwī adds some biodiversity to the dune planting and also helps manage invasive exotic perennial grasses from the landward grassed reserve, allowing grass specific herbicides to be used.

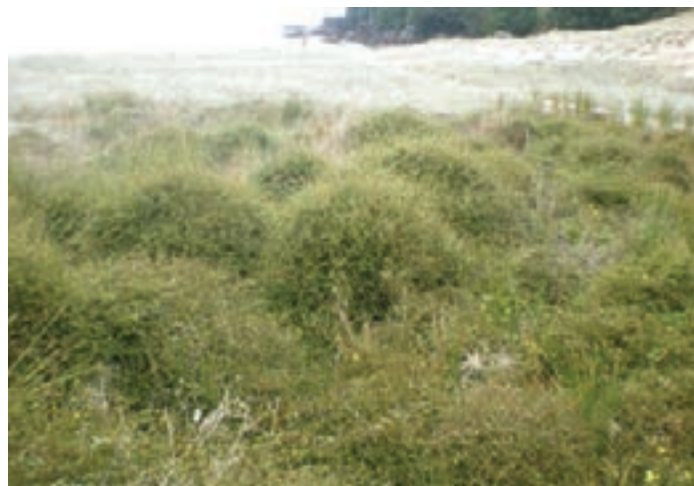
An area of pōhuehue and wīwī established at the southern end of the beach by earlier plantings continues to thrive and expand. An invasion of exotic grasses along the landward margin is being managed by ongoing spraying.

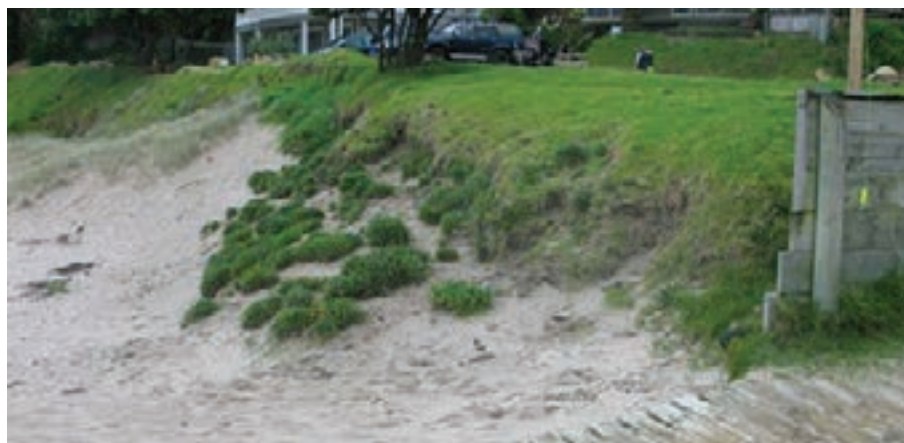
Dune area prior to works (April 2011).

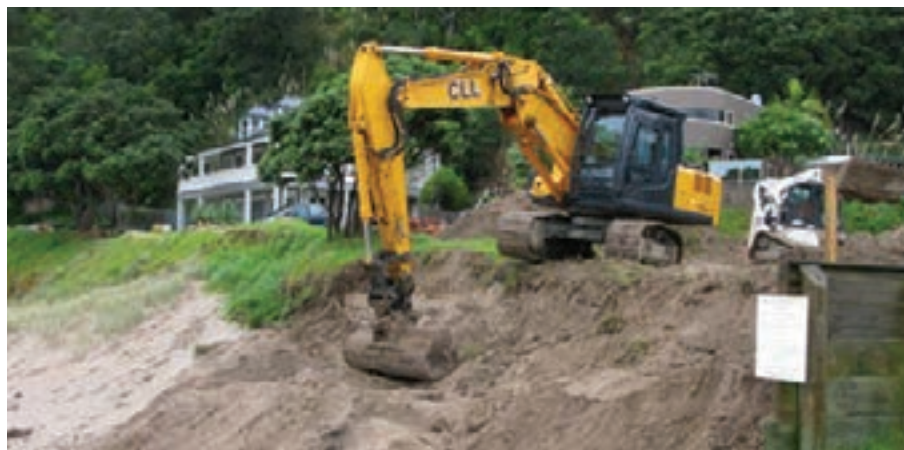
During earthworks to reshape the dune and remove rock and clay.

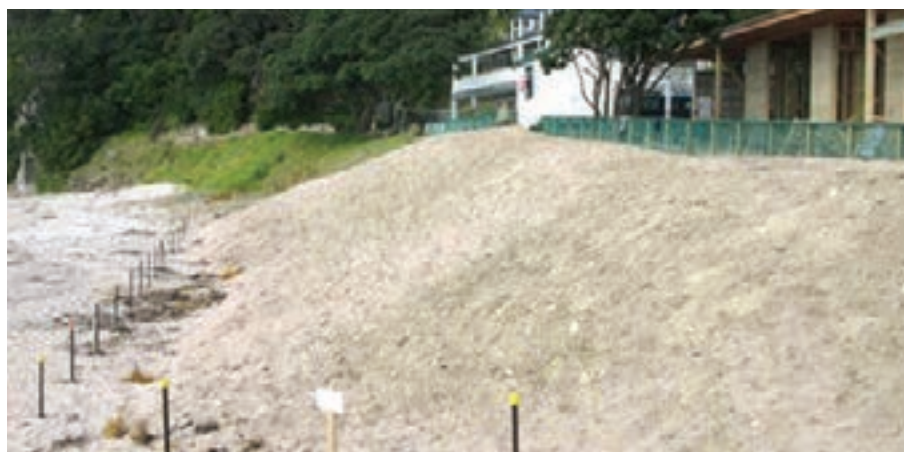
The Tairua dune area following reshaping and planting (August 2011).

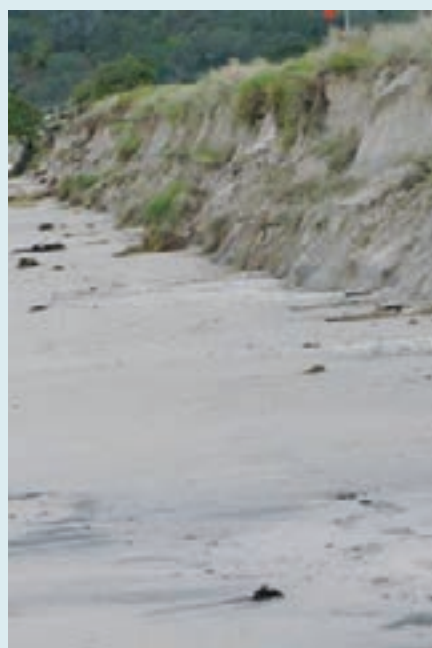
Storm cut erosion towards the southern end of Pauanui Beach. In this area, the erosion has damaged access ways and, in places, has narrowed the spinifex zone markedly. Work will be conducted in future years to restore a width of spinifex sufficient to accommodate the worst likely storm erosion.

Work in 2012 will depend on the state of the ongoing erosion. Once this erosion has ceased, dunes in the area worst affected will be reshaped to widen the spinifex zone landward sufficiently to accommodate storm cut erosion.

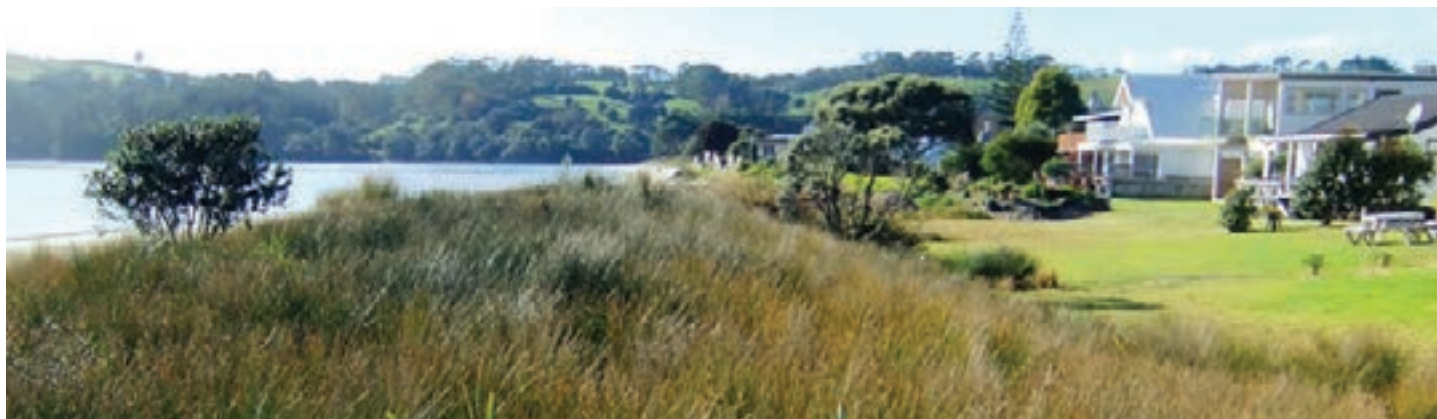
This is one year after the weeds were removed and native species such as wīwī, carex testacea, harakake, and NZ spinach were planted by local community members – a big improvement to the natural character and biodiversity values of the area.

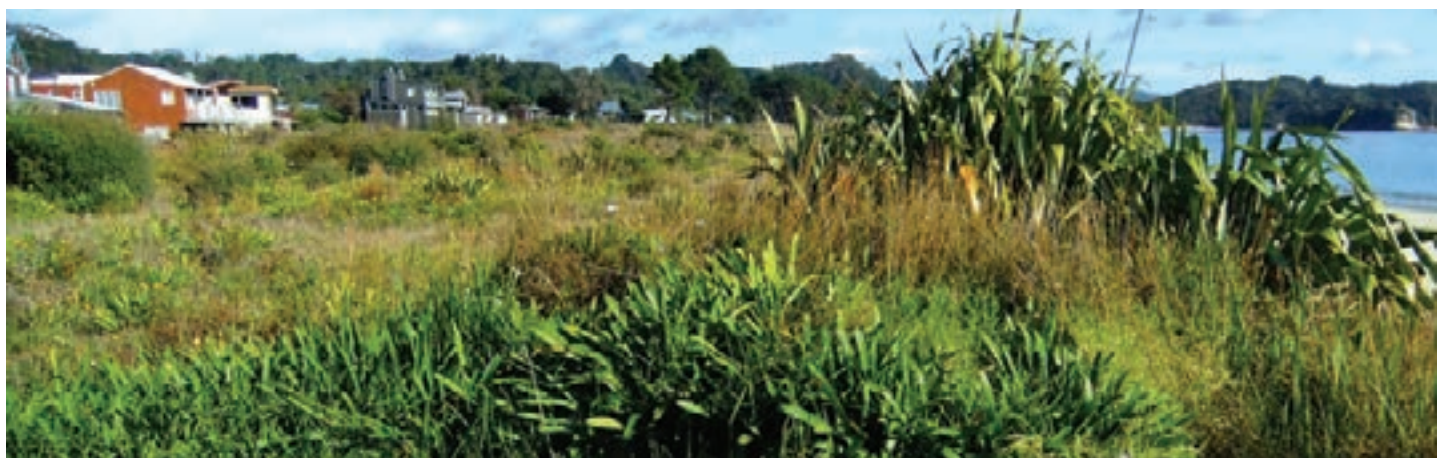
The view to the west of the restoration demonstration site showing garden escapee weeds such as agapanthus and kikuyu grass dominating the back-dune area. This is what the restoration site looked like before the exotic vegetation was cleared and planted with appropriate native species.

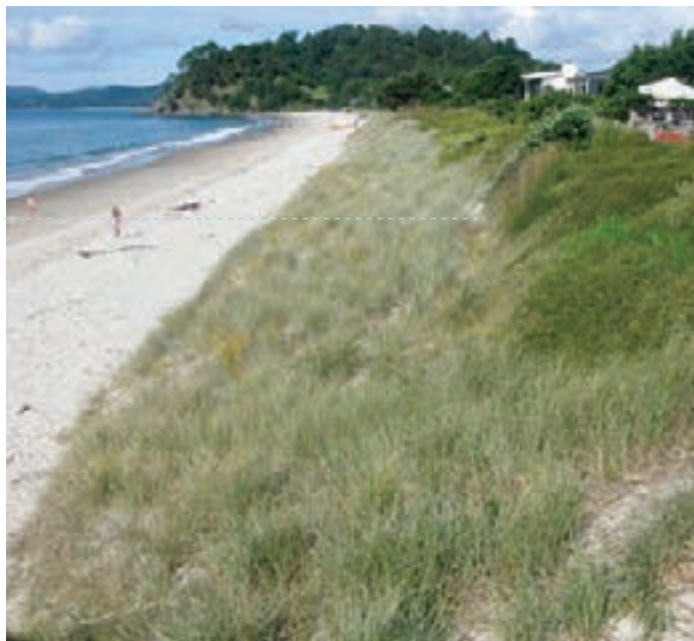
A view of restored dunes taken during Easter in 2011. Compare this with the photo of the same area taken in October 2011 to see the level of erosion. This poses no threat to property, but has narrowed the spinifex zone considerably. Together with the seaward spread of exotic vegetation narrowing the spinifex zone from landward, this indicates the need for a 'whole of frontal dune' approach to restoration at this site.

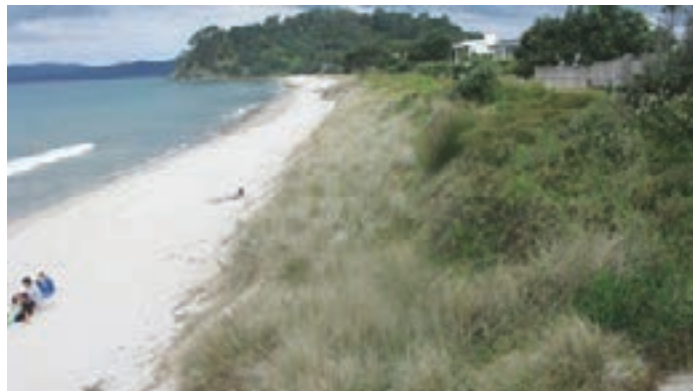
An October 2011 view looking south along the restored dune and plantings, which are now well-established. However, note the recent erosion near this area, which has completely removed the spinifex zone over short lengths of the beach.

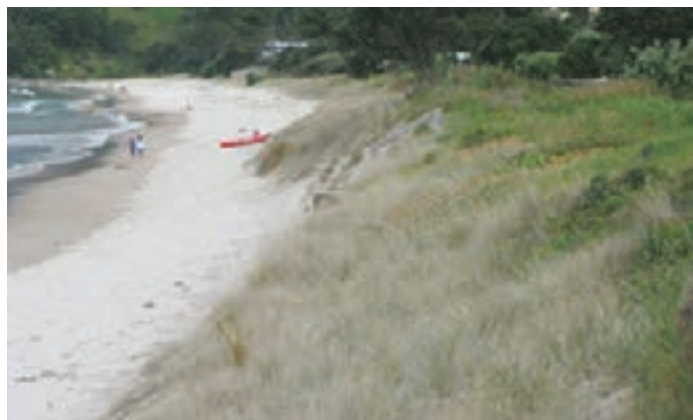
A view of restored dunes and planting showing erosion embayments formed over the last 12-18 months. The erosion is relatively minor and the native vegetation will self-repair the dunes in the absence of further events. Note also the invasive exotic vegetation beginning to advance down into the new plantings, indicating the need for a 'whole of frontal dune' approach to restoration at this site in the medium term. It is hoped to do a demonstration area utilising this approach in 2012.

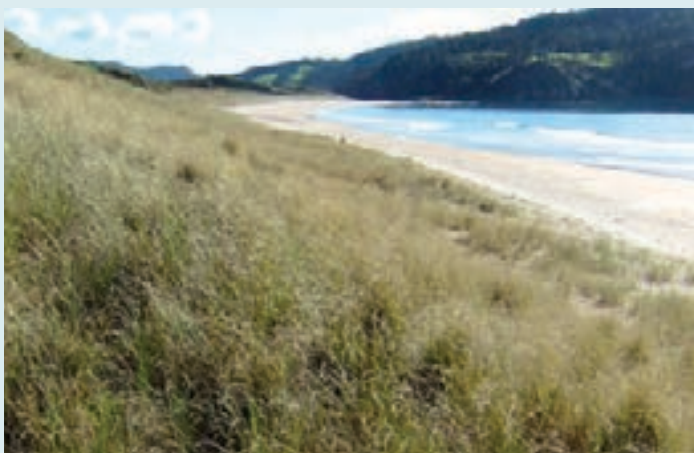
Hotwater Beach has an impressive natural dune system with a thick cloak of the native spinifex grass. Note the gentle slope and wide buffer created by the native vegetation.

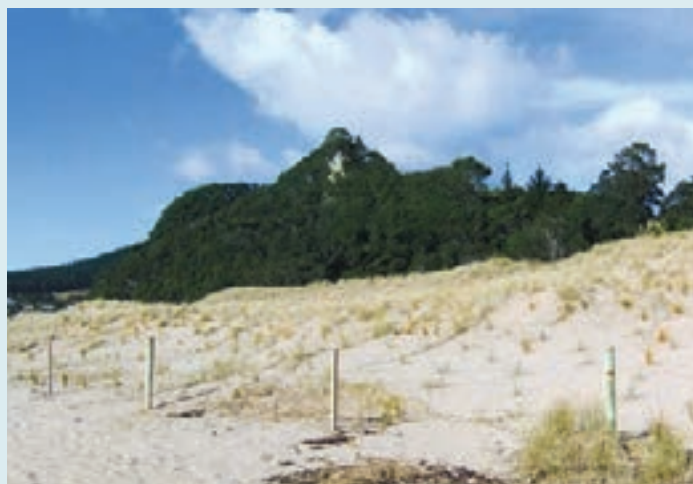
The dune area planted by community members in 2011 is looking healthy after six months' growth. These new plantings are still vulnerable, so they are protected by fencing to prevent damage by pedestrians.

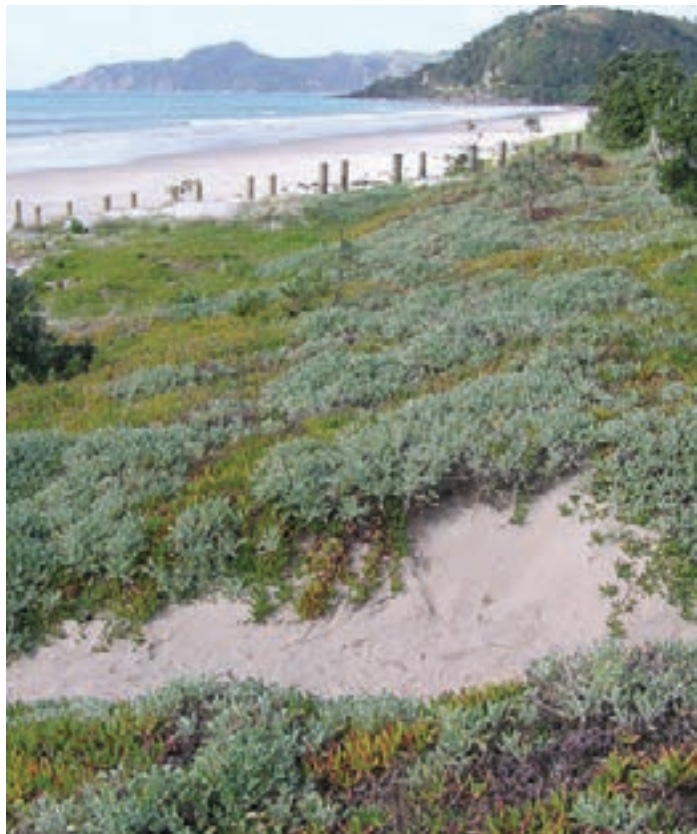
Before and after comparison showing how the dune in front of the Kenwood Drive carpark looked before the exotic plants were removed in 2009 (left) with the current view (right) showing a healthy cover of the native spinifex following the dune restoration.

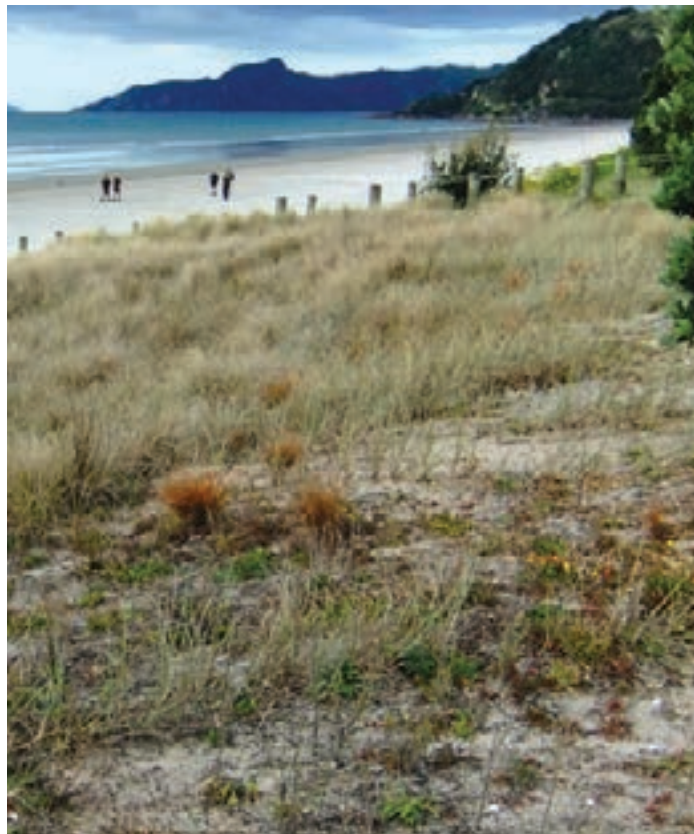
Current view of the restoration demonstration site area fronting properties along Kenwood Drive. Given the success of the earlier plantings, further planting was conducted to thicken the vegetation up. It is hoped to expand this area further alongshore in 2012, subject to the outcome of planned community consultation.

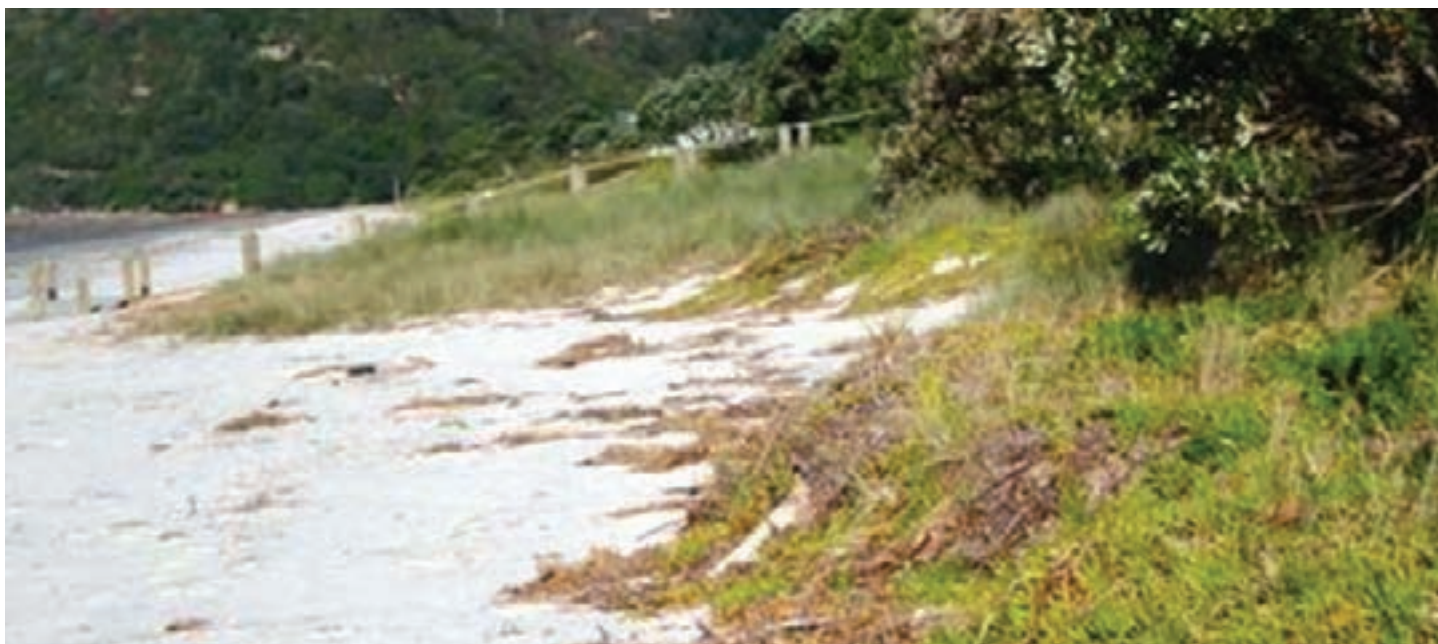
View looking south alongshore towards the spinifex area restored in 2009 and 2010. This vegetation is now well-established and has built the dune seaward some distance. The seaward extent of the native dune vegetation is marked relative to the dunes dominated by exotic vegetation in the immediate foreground, providing a good indication of the superior sand-trapping ability of the native dune vegetation.

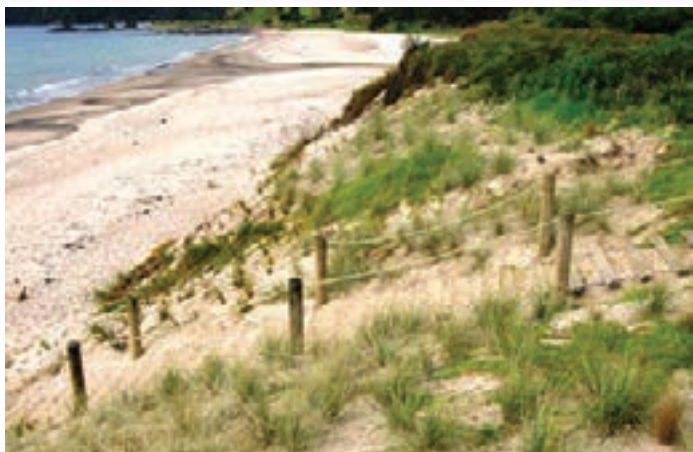
An April 2011 view of dune restoration and access management works undertaken in 2010 at Kuaotunu West. Inspections during the year indicate that the spinifex is continuing to establish well and expand. However, invasion of exotic perennial grasses from the grassed reserve to landward continues to require ongoing maintenance and further work will be required to address this matter. It is hoped to conduct this further work in 2012.

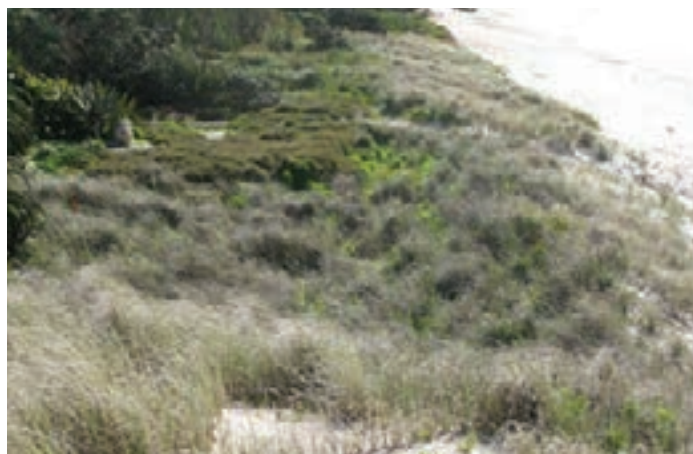
An October 2011 view over the dune area reshaped and restored in 2009 and 2010. The planting is now well-established. Invasion of exotic perennial grasses is still evident in places, but this continues to be addressed with spraying.

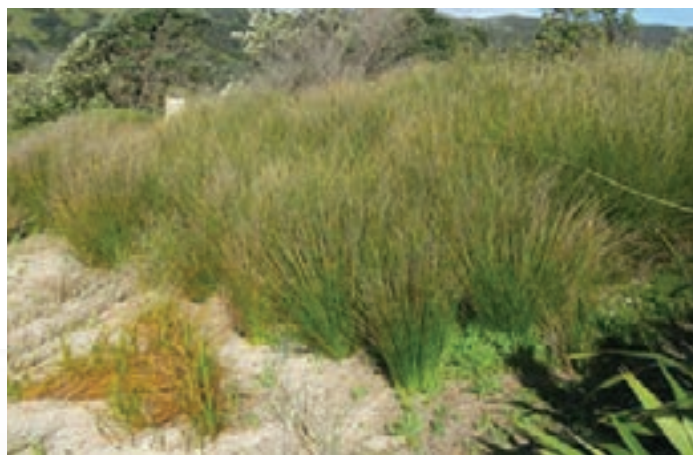
A dense clump of knobby club rush is now well-established, and is part of a larger area restored in 2009 and 2010.

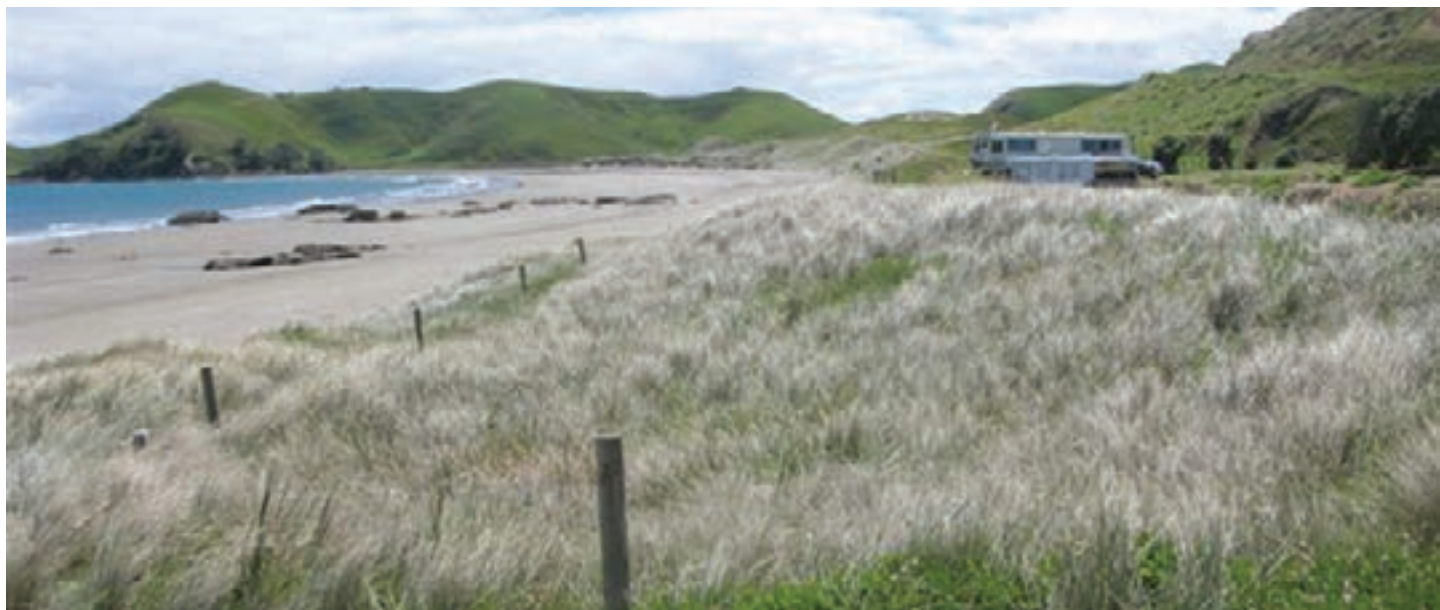
View of the area of dune restoration undertaken in 2008 shows the ongoing success of this work.

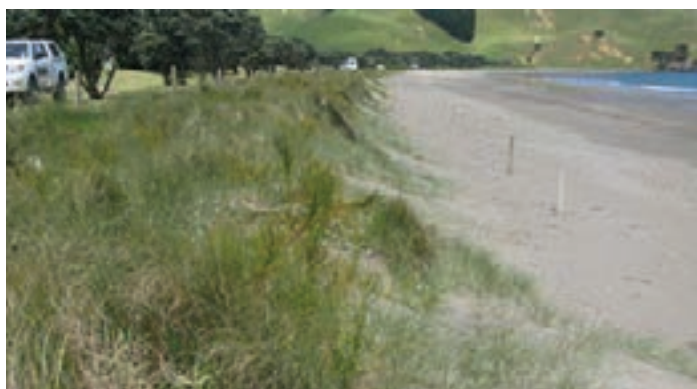
Another November 2011 view of the 2010 restoration area shows active seaward growth of the spinifex following erosion in late 2010.

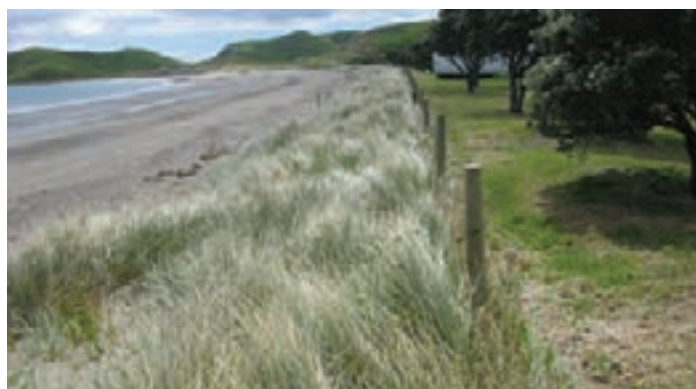
Another view of the area restored in 2010 showing the planting now well established. In the absence of serious erosion requiring the spinifex zone to be widened landward, future work here will largely focus on maintenance.

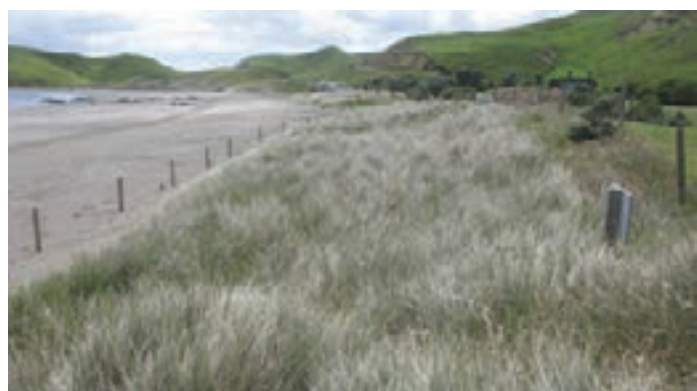
November 2011 view of area restored in 2009 shows the wide and dense spinifex zone that has now established.

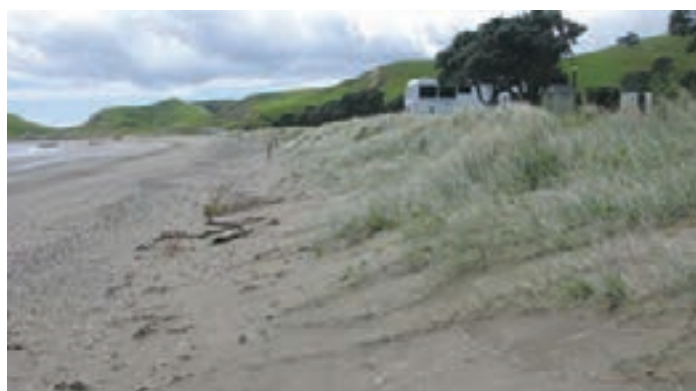
View of the area restored in 2009 and 2010 showing dense spinifex vegetation now established and actively extending seaward. The planting was extended further westward in 2011 and a spinifex dune now exists along most relevant areas of the foreshore fronting the camping ground.

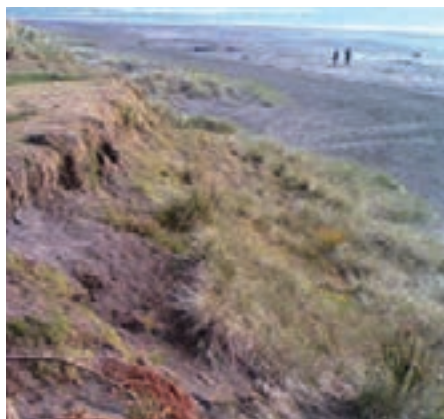
The dunes at Wainamu had been highly modified in the past and were eroding badly without a cover of native dune species to trap wind-blown sand.

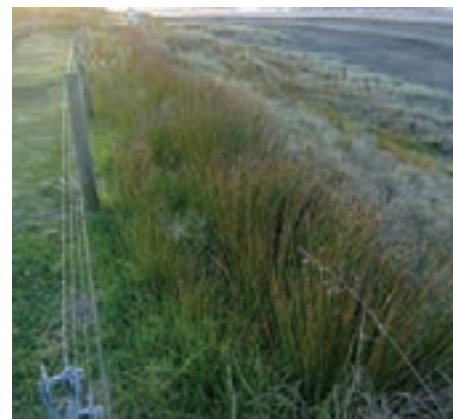
The restored dune at Wainamu one year after the first stage of reshaping and planting. A strip of wīwī has been planted between the spinifex and grassed reserve to prevent kikuyu grass encroaching into the dune area. Note the amount of accretion in just one year, with the spinifex growing seaward by up to two metres through the fencing at the bottom of the dune.

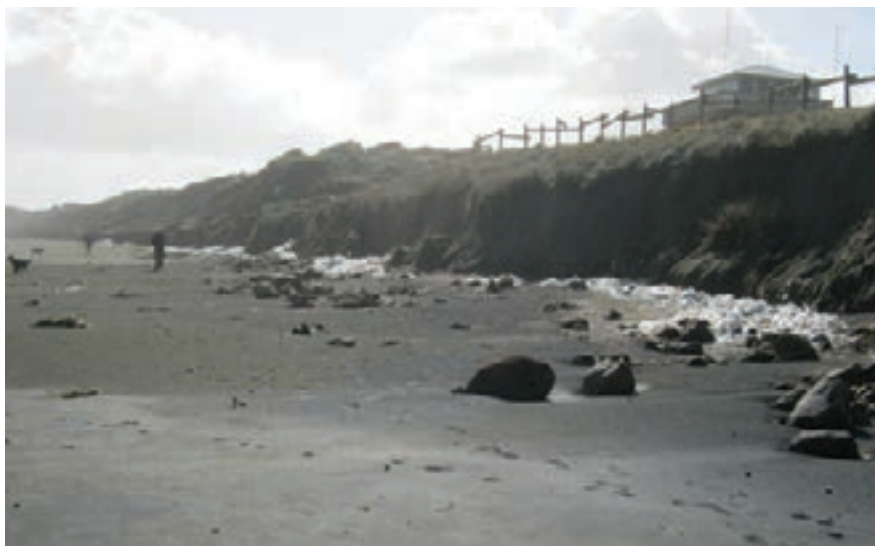
The large storm that hit the west coast in July 2011 had a big impact on the Port Waikato beach and dunes. The erosion was more dramatic and obvious at Sunset Beach where the dunes have been highly modified in the past to allow for the existing carpark areas. This modification has resulted in a narrowed dune width when compared with the dunes further north up the beach that can easily absorb these type of erosion events and recover naturally.

The large July swells coincided with some of the biggest tides of the year, resulting in approximately four metres of the fore-dune being lost to the sea and a significant lowering of the beach. The erosion washed away beach access ways and exposed historic fill and debris that had previously been added to the dunes.

The new local authority for this area, the Waikato District Council, reinstated access ways and undertook earthworks to remove debris that was limiting the ability of plants to become established in this area, and re-contoured the dune to natural shape. These works were followed by the planting of spinifex, pīngao, and wīwī by students from the local Te Kura Kaupapa o Te Puaha o Waikato to reinstate a natural dune.

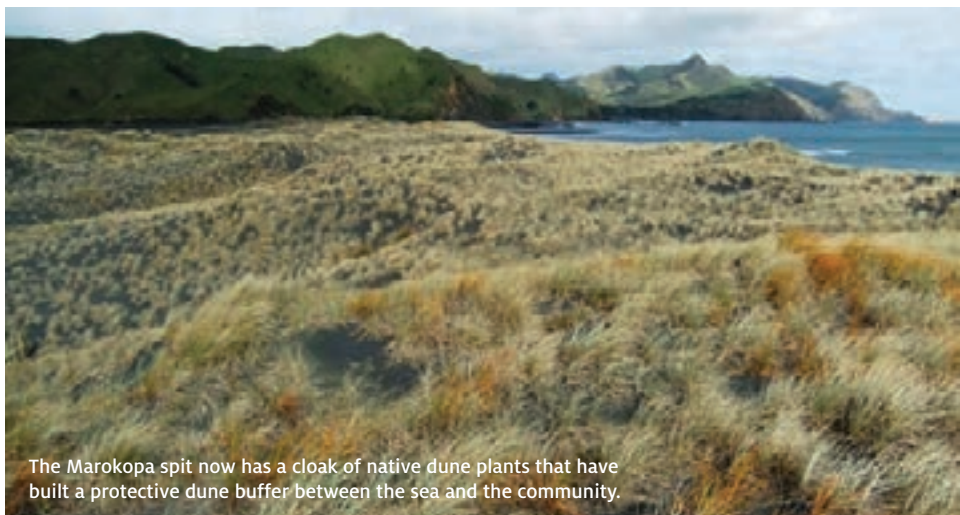
The Marokopa spit now has a cloak of native dune plants that have built a protective dune buffer between the sea and the community.

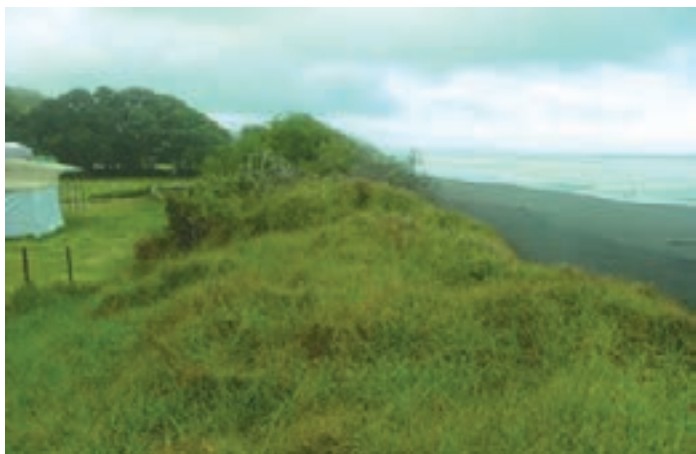
The area where the first stage of reshaping and planting took place had previously been dominated by exotic grasses and pest plants, such as box thorn, that prevent natural dune building from occurring.

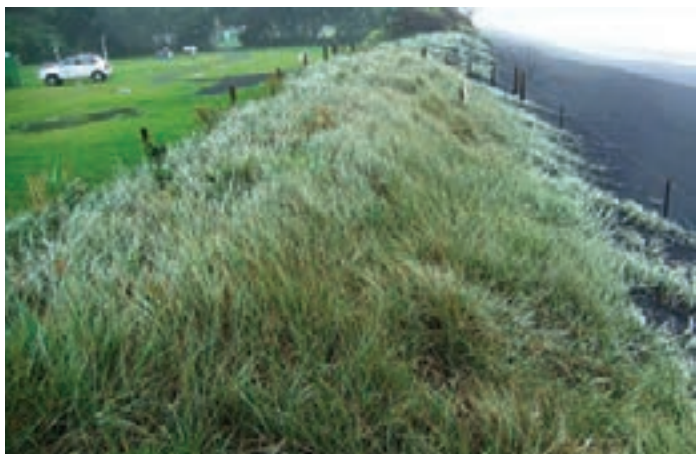
The same area 1.5 years later shows a healthy cover of native spinifex grass that is allowing the dunes to build seaward, increasing the dune buffer between the sea and campground.

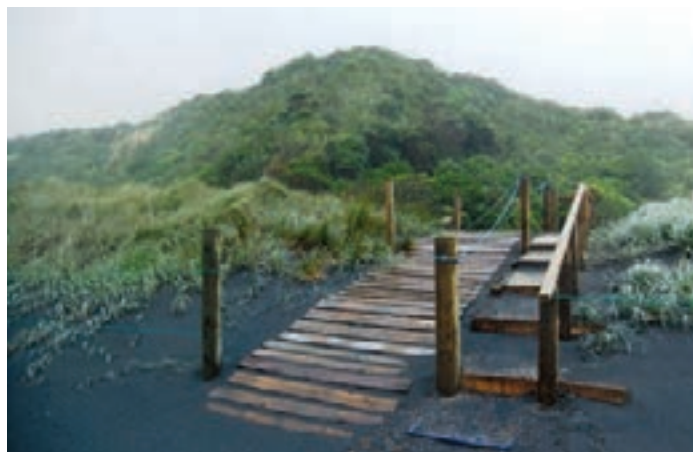
The access way contracted by local campers and campground management is helping to protect the new plantings from pedestrian damage.

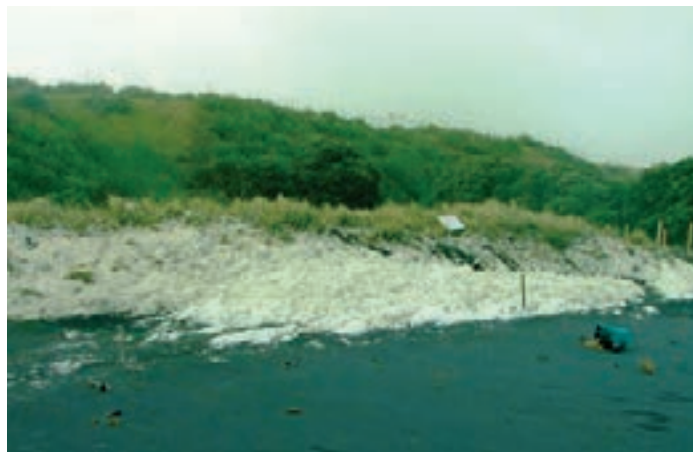
Wave run-up from the July storm left behind knee depth foam. The foam actually provides nutrients for the dune plants and growth spurts are often observed from the plants following events such as this.
